## SMALL AMALGAM

## TOOTH FRACTURE

## OLD FILLINGS

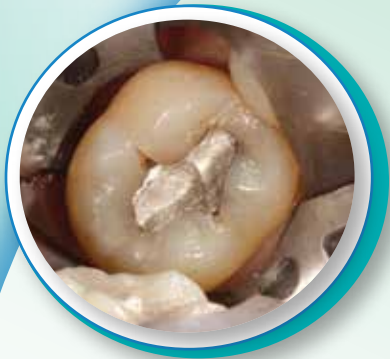
This amalgam filling was placed ten years previously. There was the possibility of leakage.

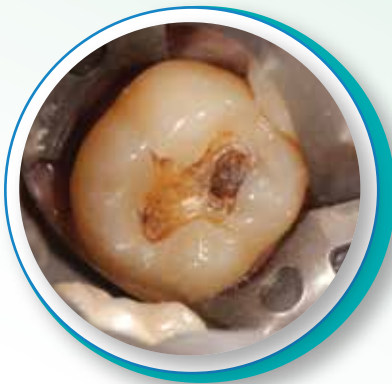
When the amalgam filling was removed there was indeed **decay**.

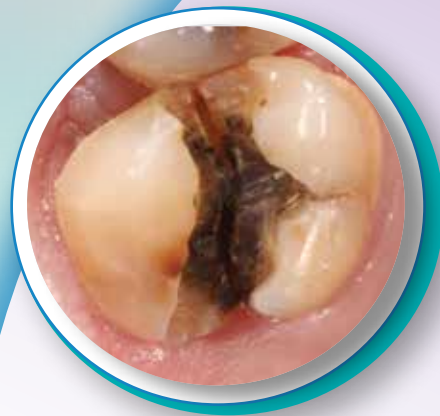
This tooth had an amalgam filling that fell out. It is now fractured. The expansion and contraction of the amalgam contributed to this fracture.

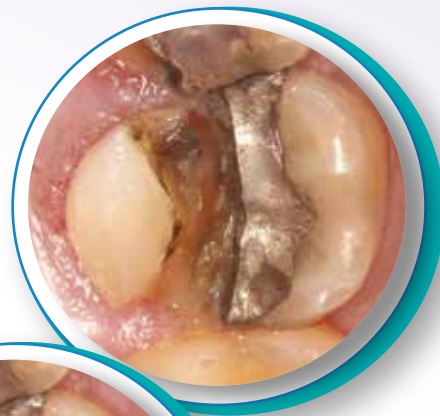
This tooth has a fracture that is very severe. The broken fragment will have to be removed and evaluated.

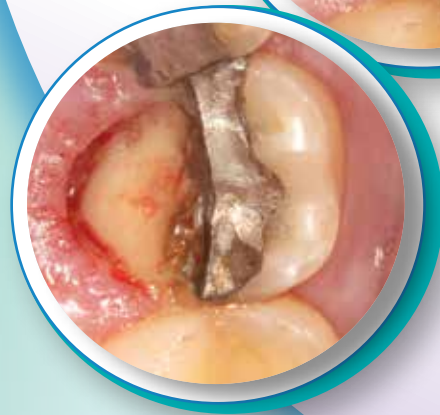
After the broken fragment was removed it was clear that the tooth had to be **extracted**.

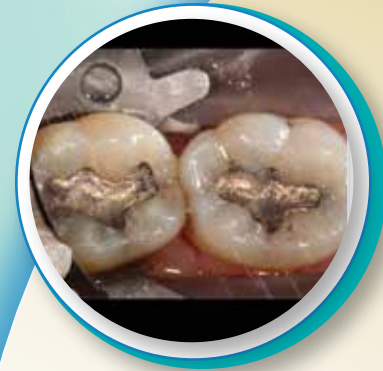
These old amalgam fillings were leaking, yet they had no symptoms to indicate a problem.

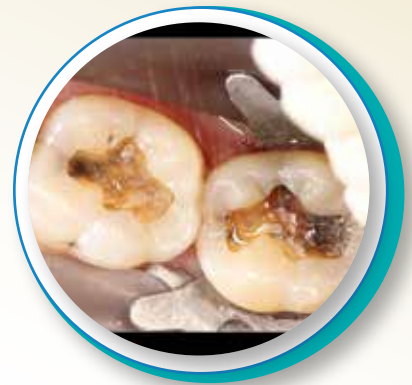
The amalgam fillings were removed. There was decay under the fillings that was caused by the leakage of the dental amalgam.
